# Manhole Inspection Summary

Manhole # S25G\_\_017MH

**Location** Address: **1217 CAREY ST**

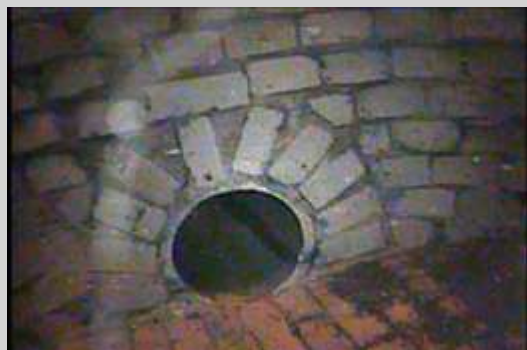
12 O'Clock Outflow

8 in. Circular Gravity Sewer  
Pipe Out @ 12 O'Clock

Pipe Height: **8.4** (in.) Rod and Bar (Angled)

Pipe Material: **Clay** ☐ Pipe Lined

Invert Depth: **9.50** (ft.) Flow Characteristics: **None**

Deposits: ☒ None ☐ Mud ☐ Sludge ☐ Debris ☐ Grease

Infiltration: **None** Pipe Seal Cond: **Sound**
